**Thermal Inspection for Electrical Equipment
Using Advanced FLIR T640 Thermal Camera**

Customer: *****

18/6/2014

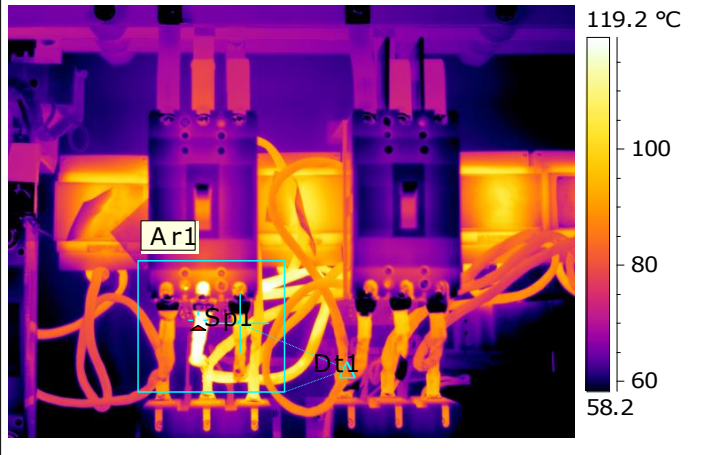
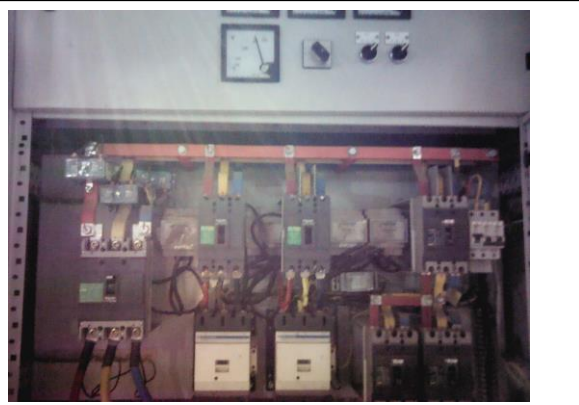
Location	South Under Al-Safeyah Bridge
Equipment	M-16

Ar1 Max. Temperature	136.9 °C
Sp1 Max. Temperature	102.2 °C
Dt1 Value	34.7 °C

Severity Rating & Recommendation			
1	Low ($\Delta = 5-10^{\circ}\text{C}$)	To be monitored	<input type="checkbox"/>
2	Medium ($\Delta = 10-35^{\circ}\text{C}$)	Repair at schedule outage	<input checked="" type="checkbox"/>
3	High ($\Delta > 35^{\circ}\text{C}$)	Repair immediately	<input type="checkbox"/>

The detected hot spot in thermal image shown above were many critical faults in filters and cables (Ar1) which are high in temperature.

In maximum load, this insulated conductor, enclosure surface (Ar1 of thermal image) model reference temperature should not exceed 50°C.

To check the loading current (in Amperes) of the secondary load side wire of the circuit breaker (S phase)
Do another thermal inspection

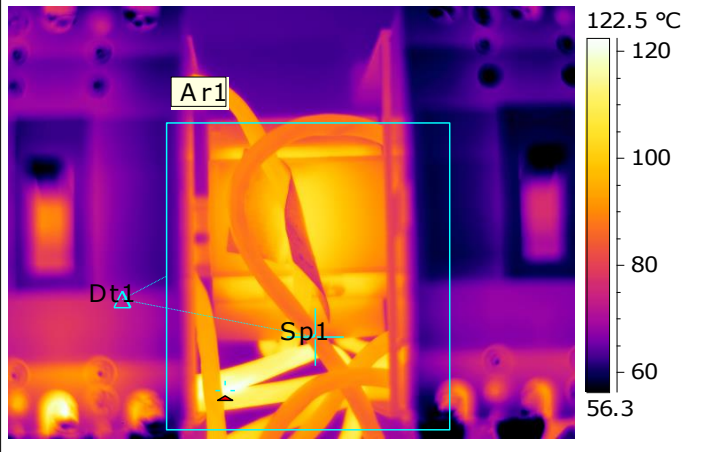
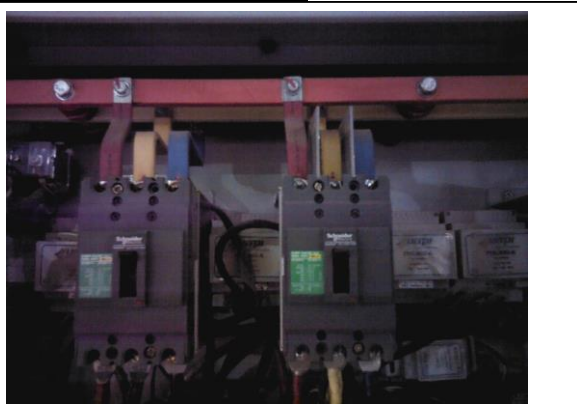
Location	South Under Al-Safeyah Bridge
Equipment	M-16

Ar1 Max. Temperature	122.5 °C
Sp1 Max. Temperature	87.0 °C
Dt1 Value	35.5 °C

1	Low ($\Delta = 5-10^{\circ}\text{C}$)	To be monitored	<input type="checkbox"/>
2	Medium ($\Delta = 10-35^{\circ}\text{C}$)	Repair at schedule outage	<input type="checkbox"/>
3	High ($\Delta > 35^{\circ}\text{C}$)	Repair immediately	<input checked="" type="checkbox"/>

The detected hot spot in thermal image shown above were many critical faults in filters and cables (Ar1) which are high in temperature.

In maximum load, this insulated conductor, enclosure surface (Ar1 of thermal image) model reference temperature should not exceed 50°C.

To checked the loading current (in Amperes) of the secondary load side wire of the circuit breaker (S phase)
Do another thermal inspection

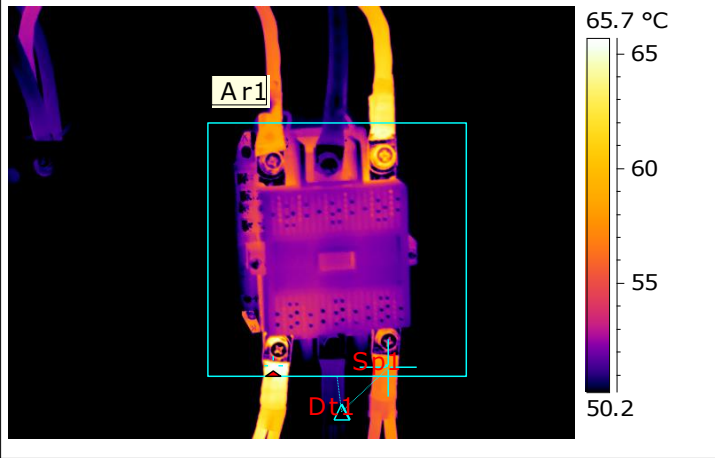
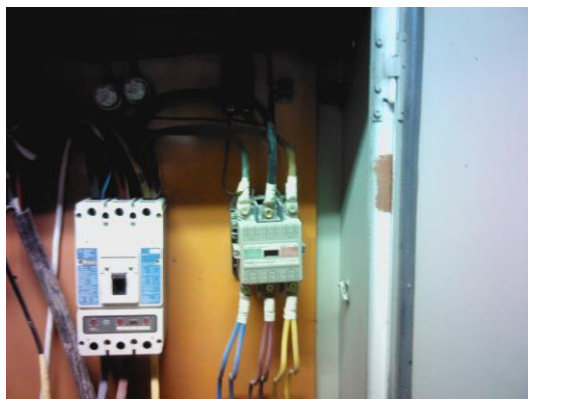
Location	South Al-Safeyah Garden
Equipment	M-10

Ar1 Max. Temperature	65.9 °C
Sp1 Max. Temperature	57.8 °C
Dt1 Value	8.2 °C

1	Low ($\Delta = 5-10^{\circ}\text{C}$)	To be monitored	<input checked="" type="checkbox"/>
2	Medium ($\Delta = 10-35^{\circ}\text{C}$)	Repair at schedule outage	<input type="checkbox"/>
3	High ($\Delta > 35^{\circ}\text{C}$)	Repair immediately	<input type="checkbox"/>

The detected hot spot in thermal image shown above was the secondary load side wire of the magnetic contactor (R phase) (Ar1) which is high in temperature.

In maximum load, this insulated conductor, enclosure surface (Ar1 of thermal image) model reference temperature should not exceed 50°C.

It is recommended to keep it under monitoring and to checked the load current in R phase of the contactor
Do another thermal inspection

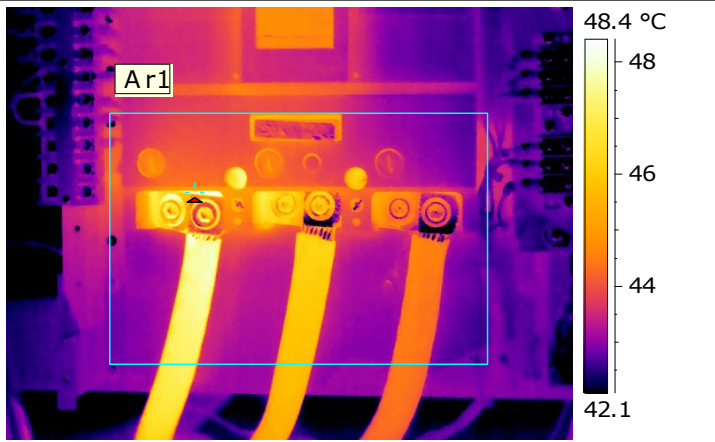
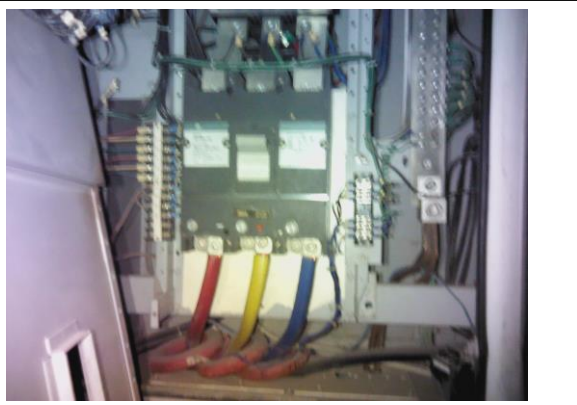
Location	South West-Versus of Dates Market
Equipment	M-6
Image File Name	FLIR0601.jpg
Image Date	06/18/2014
Image Time	7:31:05
Atmospheric Temperature	20.0 °C
Relative Humidity	50%
Emissivity	0.90
Object Distance	1.0 m
Ar1 Max. Temperature	48.4 °C

In maximum load, connectors and terminations (Ar1 of thermal image) model reference temperature should not exceed 90°C.

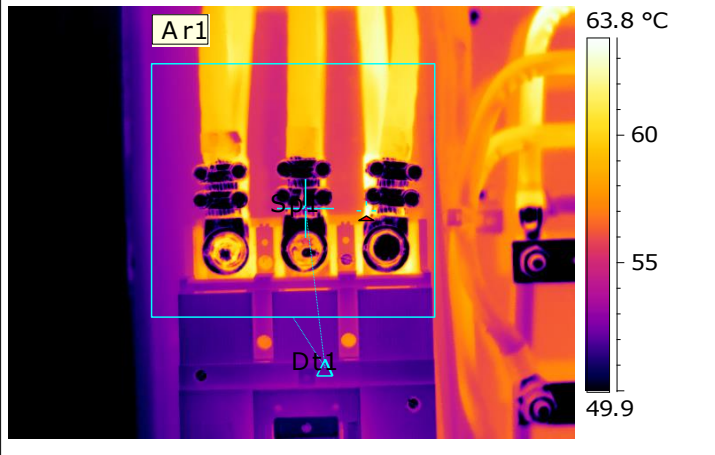
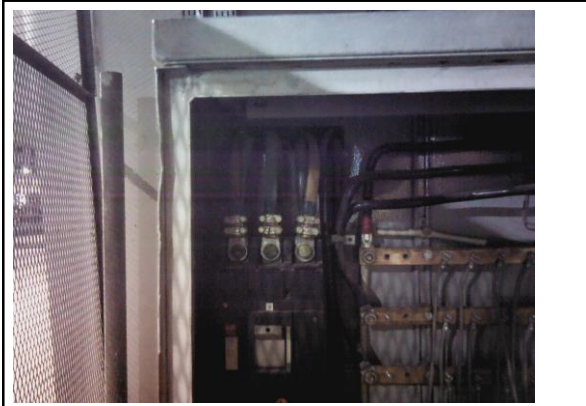
Location	South West-Under Al-Safeyah Bridge-Quba Signal
Equipment	M-15

Ar1 Max. Temperature	63.9 °C
Sp1 Max. Temperature	54.5 °C
Dt1 Value	9.4 °C

In maximum load, this connectors and terminations (Ar1 of thermal image) model reference temperature should not exceed 90°C.

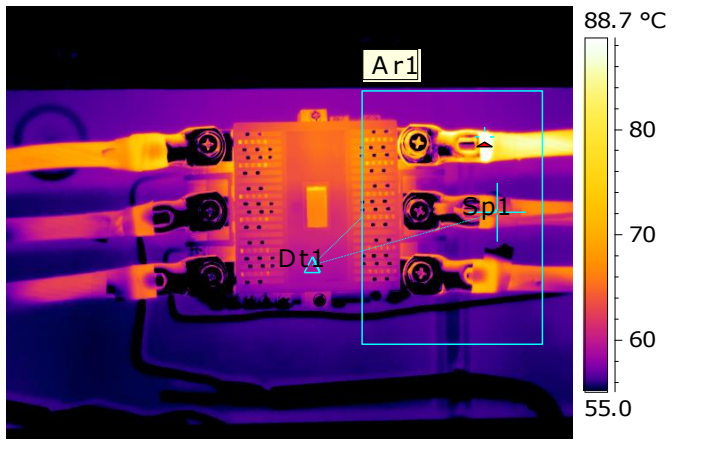
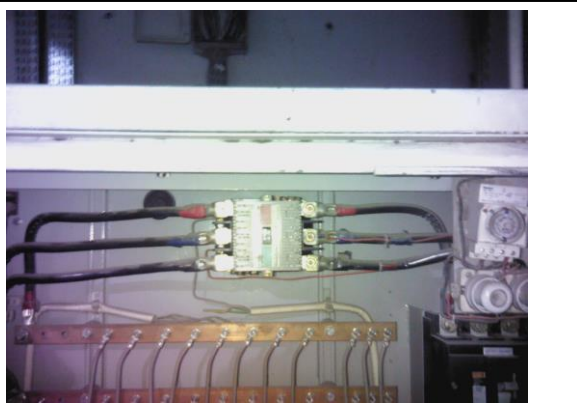
Location	South West-Under Al-Safeyah Bridge-Quba Signal
Equipment	M-15

Ar1 Max. Temperature	91.9 °C
Sp1 Max. Temperature	64.2 °C
Dt1 Value	27.7 °C

Severity Rating & Recommendation			
1	Low ($\Delta = 5-10^{\circ}\text{C}$)	To be monitored	<input type="checkbox"/>
2	Medium ($\Delta = 10-35^{\circ}\text{C}$)	Repair at schedule outage	<input checked="" type="checkbox"/>
3	High ($\Delta > 35^{\circ}\text{C}$)	Repair immediately	<input type="checkbox"/>

The detected hot spot in thermal image shown above was the secondary load side wire of the magnetic contactor (T phase) (Ar1) which is high in temperature.

In maximum load, this insulated conductor, enclosure surface (Ar1 of thermal image) model reference temperature should not exceed 50°C.

- To check the loading current of the secondary load side wire of the contactor (T phase)
- To check all cable terminations
- Do another thermal inspection

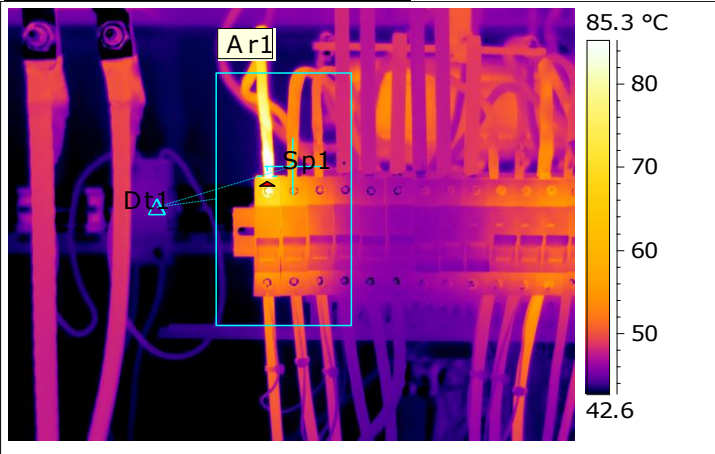
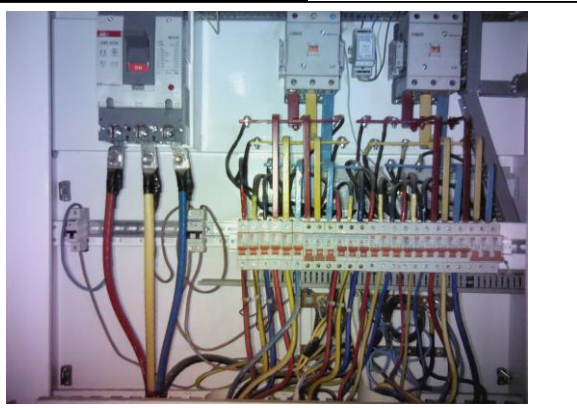
Location	Al-Anbareyah-Under(Harbi Bridge or the 60 bridge)
Equipment	The new panel

Ar1 Max. Temperature	95.6 °C
Sp1 Max. Temperature	57.6 °C
Dt1 Value	38.1 °C

Severity Rating & Recommendation			
1	Low ($\Delta = 5-10^{\circ}\text{C}$)	To be monitored	<input type="checkbox"/>
2	Medium ($\Delta = 10-35^{\circ}\text{C}$)	Repair at schedule outage	<input type="checkbox"/>
3	High ($\Delta > 35^{\circ}\text{C}$)	Repair immediately	<input checked="" type="checkbox"/>

The detected hot spot in thermal image shown above was the secondary load side wire of the miniature circuit breaker (R phase) (Ar1) which is high in temperature.

In maximum load, this insulated conductor, enclosure surface (Ar1 of thermal image) model reference temperature should not exceed 50°C.

- To check the loading current of the secondary load side wire of the contactor (R phase)
- To check all cable terminations
- Do another thermal inspection

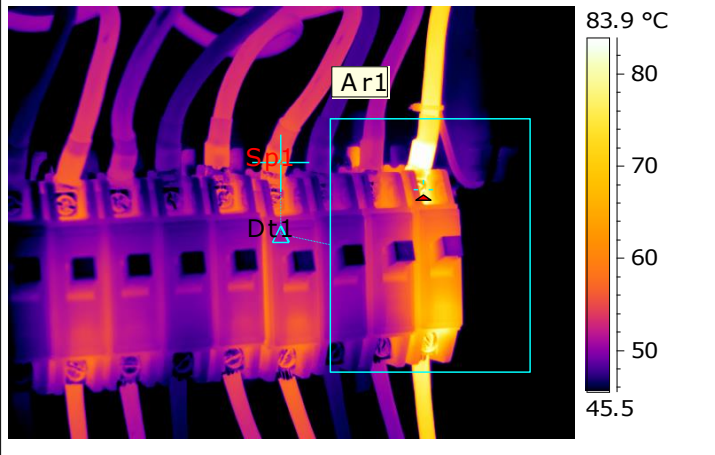
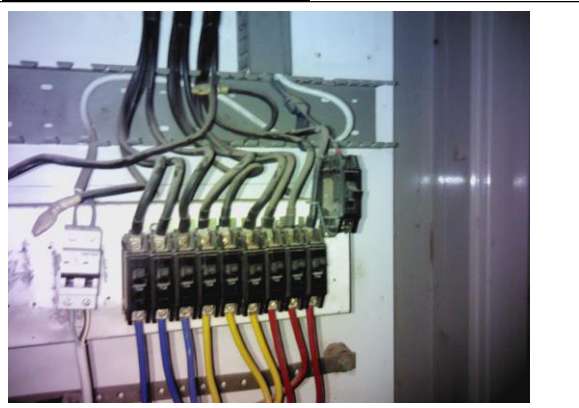
Location	The 60 Street-Al-Amarah-Versus of Marriott hotel
Equipment	M-13

Ar1 Max. Temperature	84.9 °C
Sp1 Max. Temperature	56.6 °C
Dt1 Value	28.3 °C

Severity Rating & Recommendation			
1	Low ($\Delta = 5-10^{\circ}\text{C}$)	To be monitored	<input type="checkbox"/>
2	Medium ($\Delta = 10-35^{\circ}\text{C}$)	Repair at schedule outage	<input checked="" type="checkbox"/>
3	High ($\Delta > 35^{\circ}\text{C}$)	Repair immediately	<input type="checkbox"/>

The detected hot spot in thermal image shown above was the secondary load side wire of the miniature circuit breaker (T phase) (Ar1) which is high in temperature.

In maximum load, this insulated conductor, enclosure surface (Ar1 of thermal image) model reference temperature should not exceed 50°C.

- To check the loading current of the secondary load side wire of the contactor (T phase)
- To check all cable terminations
- Do another thermal inspection

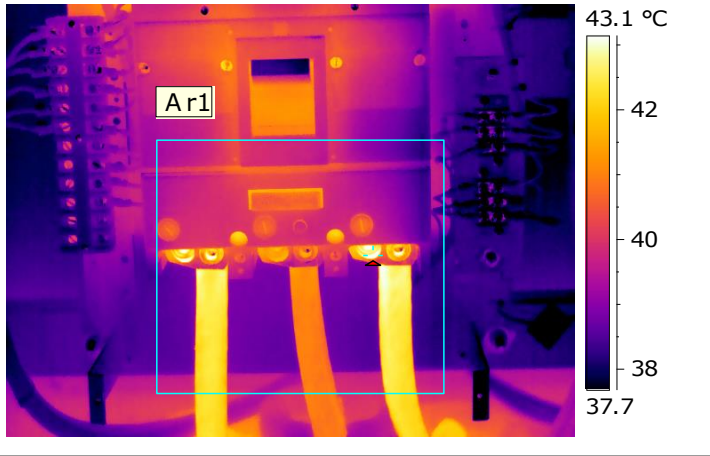
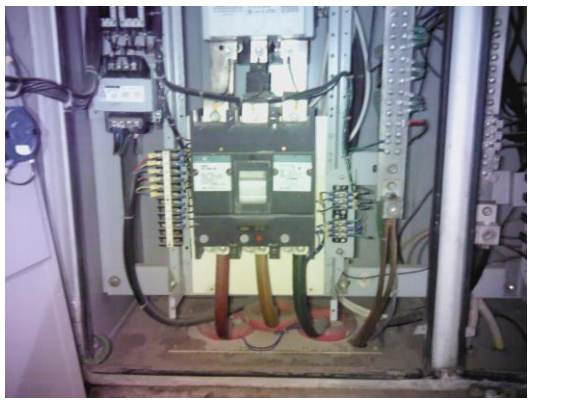
Location	South west-Near Abu Baker Al-seddeque mosque
Equipment	M-13

Ar1 Max. Temperature	43.5 °C
----------------------	---------

In maximum load, this connectors and terminations (Ar1 of thermal image) model reference temperature should not exceed 90°C.

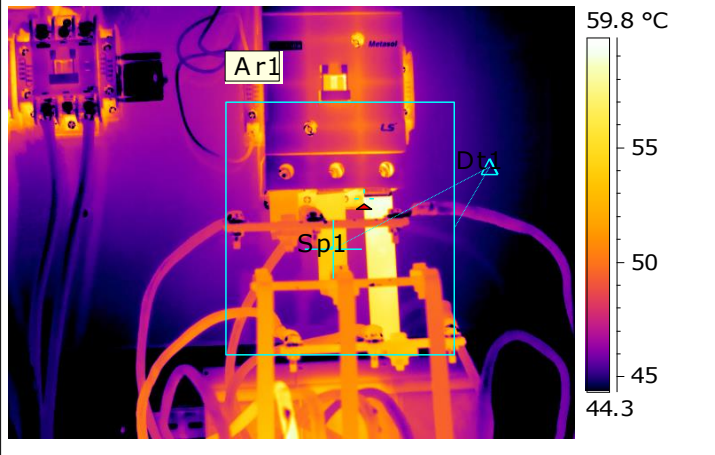
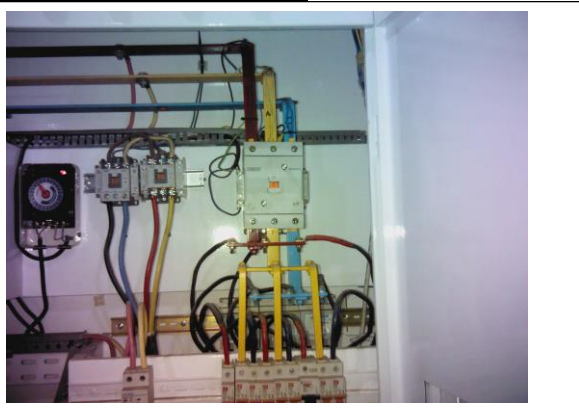
Location	West-Al-Salam Road- Wasel Al-Thahabe
Equipment	M-12

Ar1 Max. Temperature	59.1 °C
Sp1 Max. Temperature	53.8 °C
Dt1 Value	5.3 °C

In maximum load, this connectors and terminations (Ar1 of thermal image) model reference temperature should not exceed 90°C.
