**Thermography Inspection for Electrical Equipment  
at  
\*\*\*\*\***

**Date:  
5-8/6/2014**

**Thermal Inspection for Electrical Equipment  
Using Advanced FLIR T640 Thermal Camera**

**Customer: \*\*\*\*\***

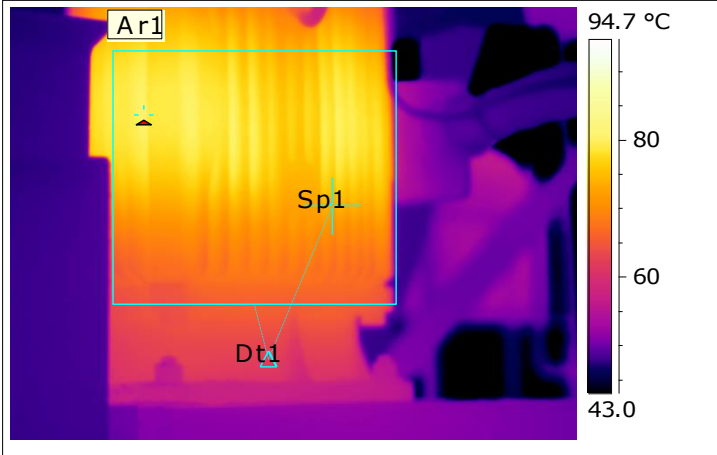
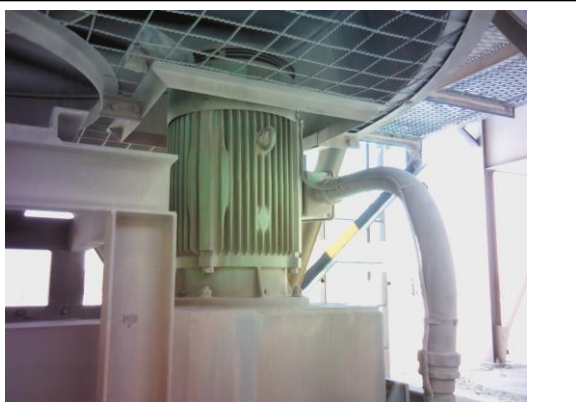
Location	GT No.21 Auxiliaries
Equipment	Disc cavity cooling motor & belt A

Ar1 Max. Temperature	80.2 °C
Ar2 Max. Temperature	72.6 °C
Dt1 Value	7.6 °C

In maximum load, this AC motor, field windings (Ar1 of thermal image) model reference temperature should not exceed 100°C.

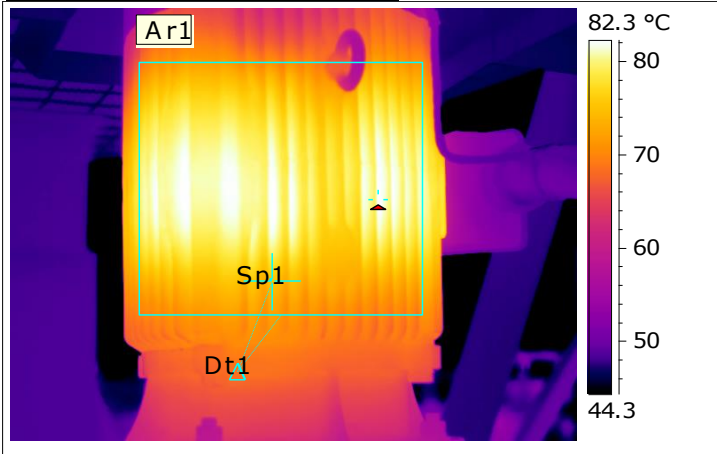
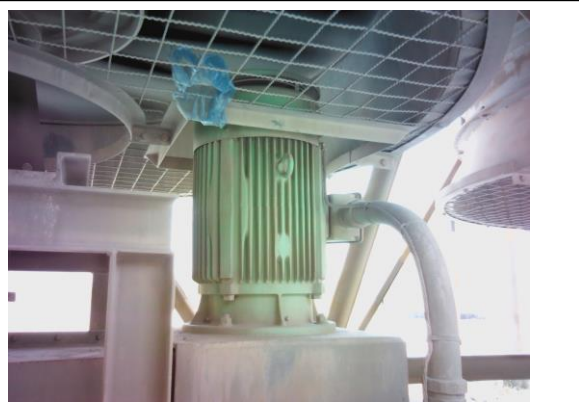
Location	GT No.21 Auxiliaries
Equipment	Disc cavity cooling motor & belt B

Ar1 Max. Temperature	82.6 °C
Ar2 Max. Temperature	75.1 °C
Dt1 Value	7.5 °C

In maximum load, this AC motor, field windings (Ar1 of thermal image) model reference temperature should not exceed 100°C.

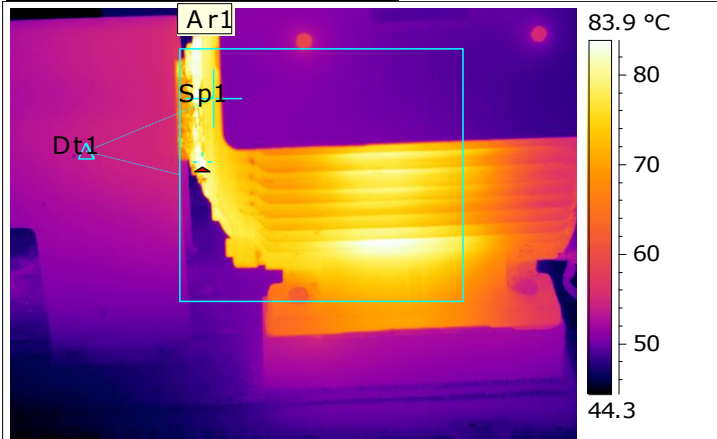
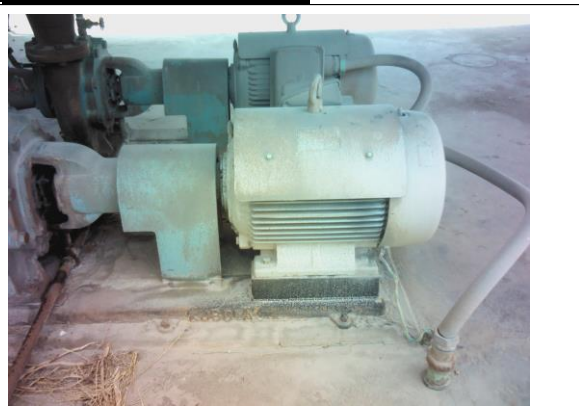
Location	GT No.21 Auxiliaries
Equipment	Water tank motor A

Ar1 Max. Temperature	84.4 °C
Ar2 Max. Temperature	75.2 °C
Dt1 Value	9.2 °C

In maximum load, this bearing, plain types material of the motor (Ar1 of thermal image) model reference temperature should not exceed 121°C.

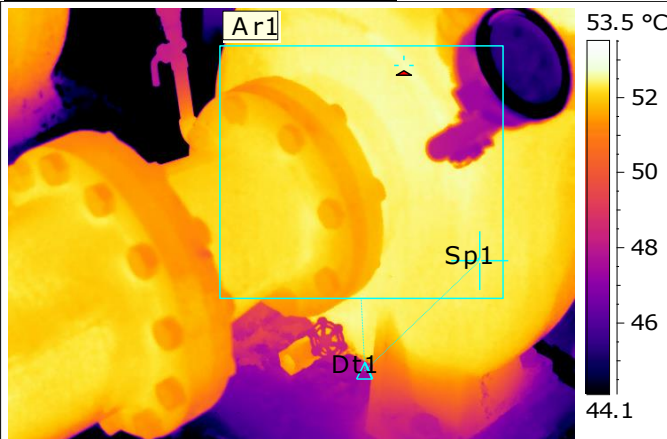
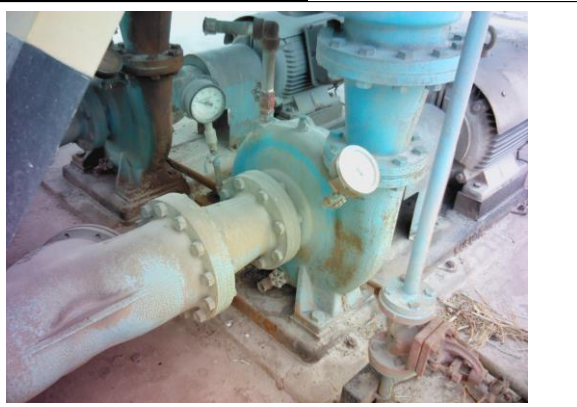
Location	GT No.21 Auxiliaries
Equipment	Centrifugal Pump A

Ar1 Max. Temperature	52.7 °C
Sp1 Max. Temperature	52.4 °C
Dt1 Value	0.3 °C

In maximum load, this bearing, plain types material of the gearbox (Ar1 of thermal image) model reference temperature should not exceed 121°C.

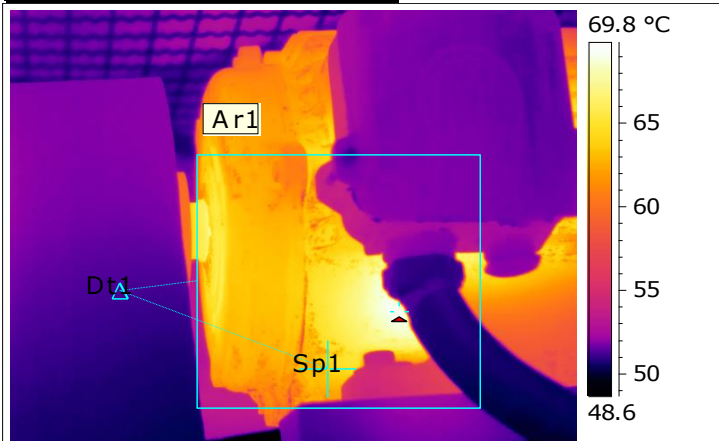
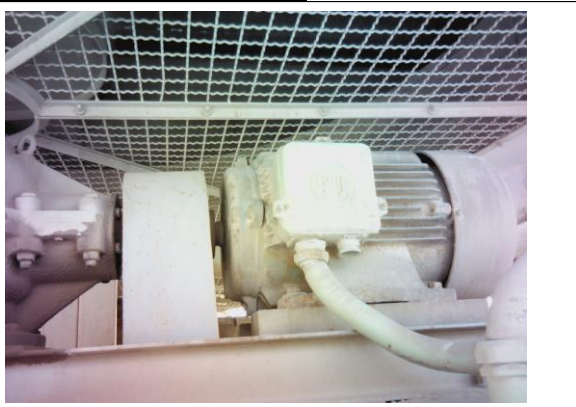
Location	GT No.7 Auxiliaries
Equipment	Lube oil cooling motor 1

Ar1 Max. Temperature	69.1 °C
Sp1 Max. Temperature	63.4 °C
Dt1 Value	5.7 °C

In maximum load, this AC motor, field windings (Ar1 of thermal image) model reference temperature should not exceed 100°C.

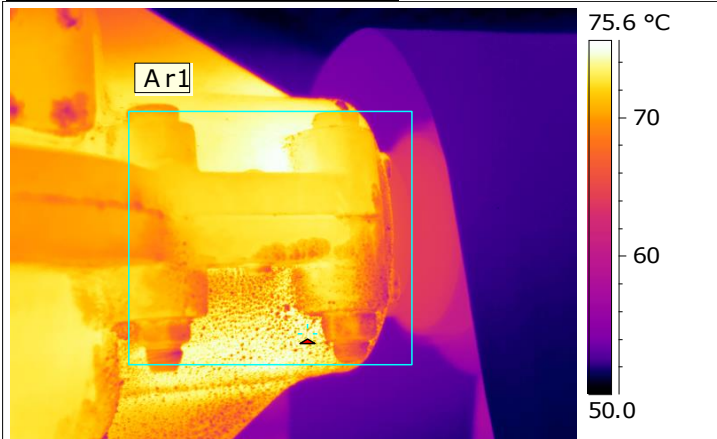
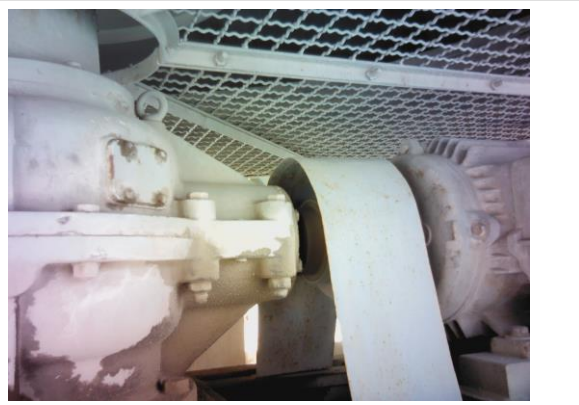
Location	GT No.7 Auxiliaries
Equipment	Gearbox 1

Ar1 Max. Temperature	75.2 °C
----------------------	---------

In maximum load, this bearing, plain types material of the gearbox (Ar1 of thermal image) model reference temperature should not exceed 121°C.

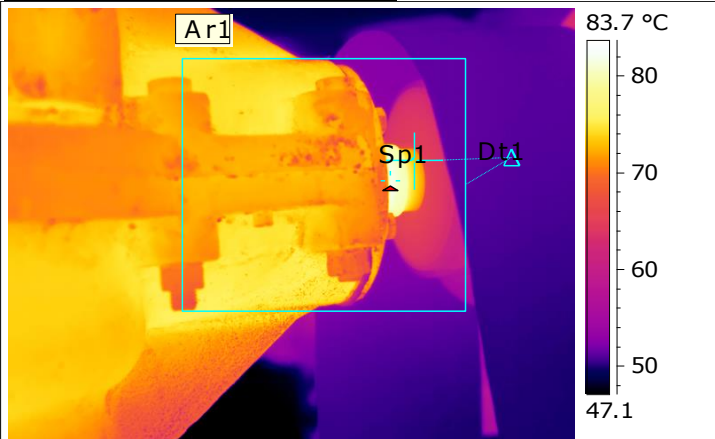
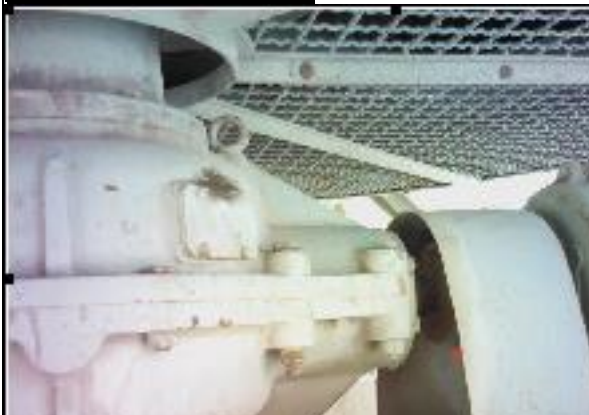
Location	GT No.7 Auxiliaries
Equipment	Gearbox 2

Ar1 Max. Temperature	81.7 °C
Sp1 Max. Temperature	72.8 °C
Dt1 Value	8.9 °C

In maximum load, this bearing, plain types material of the gearbox (Ar1 of thermal image) model reference temperature should not exceed 121°C.

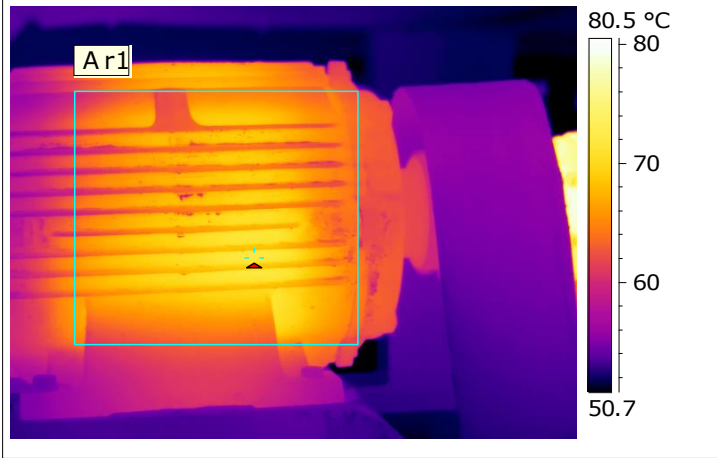
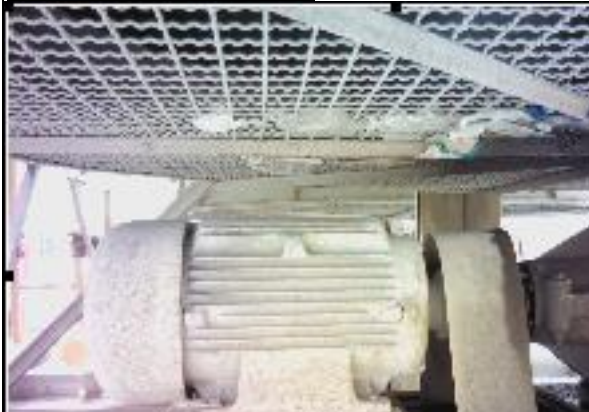
Location	GT No.7 Auxiliaries
Equipment	Lube oil cooling motor 3

Ar1 Max. Temperature	71.8 °C
----------------------	---------

In maximum load, this AC motor, field windings (Ar1 of thermal image) model reference temperature should not exceed 100°C.

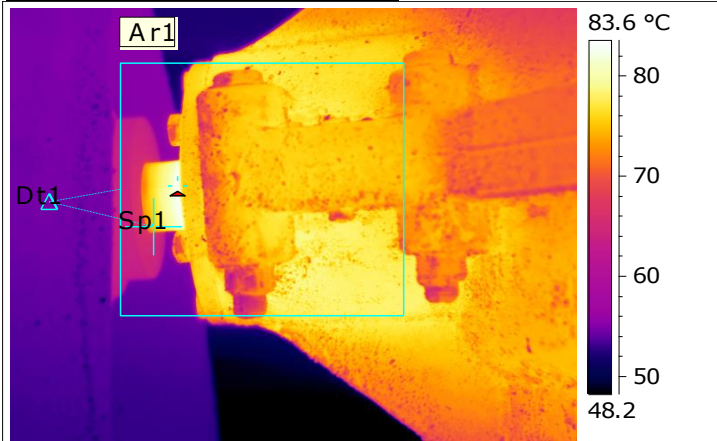
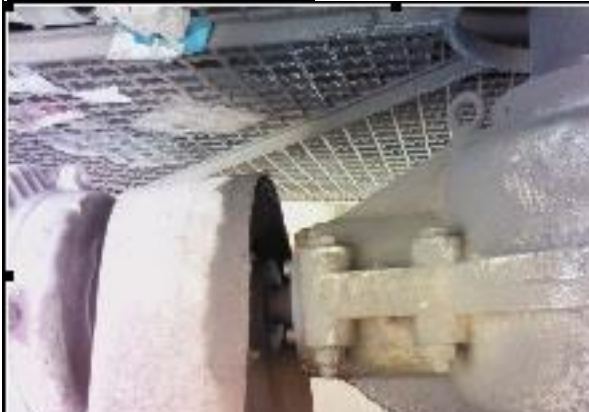
Location	GT No.7 Auxiliaries
Equipment	Gearbox 3

Ar1 Max. Temperature	82.9 °C
Sp1 Max. Temperature	75.2 °C
Dt1 Value	7.7 °C

In maximum load, this bearing, plain types material of the gearbox (Ar1 of thermal image) model reference temperature should not exceed 121°C.

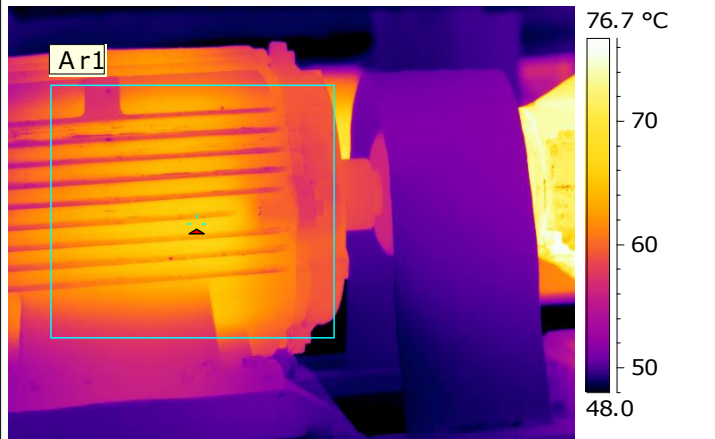
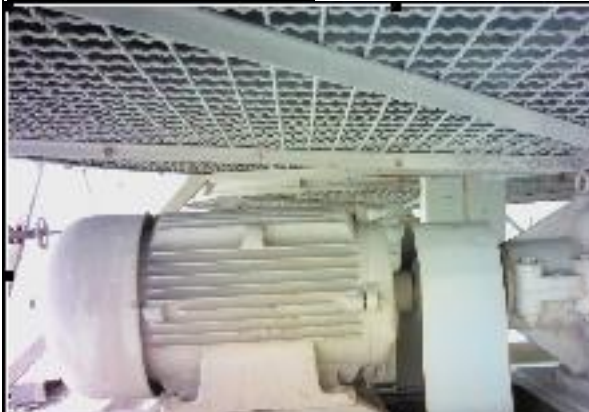
Location	GT No.7 Auxiliaries
Equipment	Lube oil cooling motor 4

Ar1 Max. Temperature	66.4 °C
----------------------	---------

In maximum load, this AC motor, field windings (Ar1 of thermal image) model reference temperature should not exceed 100°C.

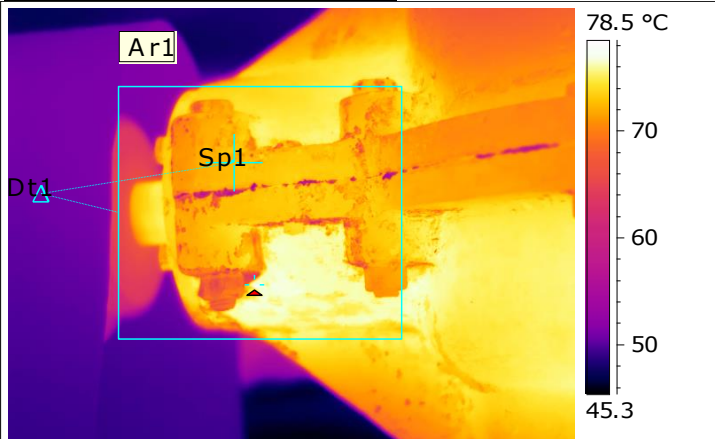
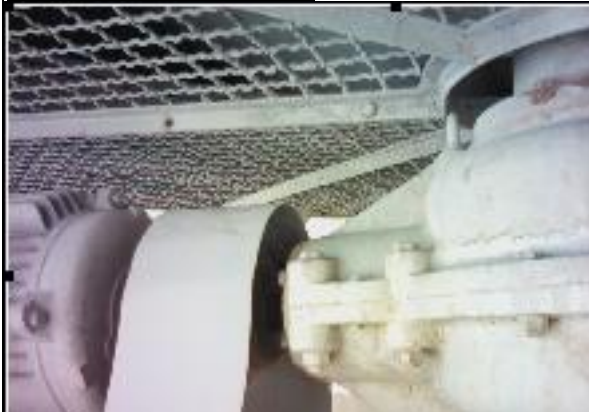
Location	GT No.7 Auxiliaries
Equipment	Gearbox 4

Ar1 Max. Temperature	76.7 °C
Sp1 Max. Temperature	73.4 °C
Dt1 Value	4.0 °C

In maximum load, this bearing, plain types material of the gearbox (Ar1 of thermal image) model reference temperature should not exceed 121°C.

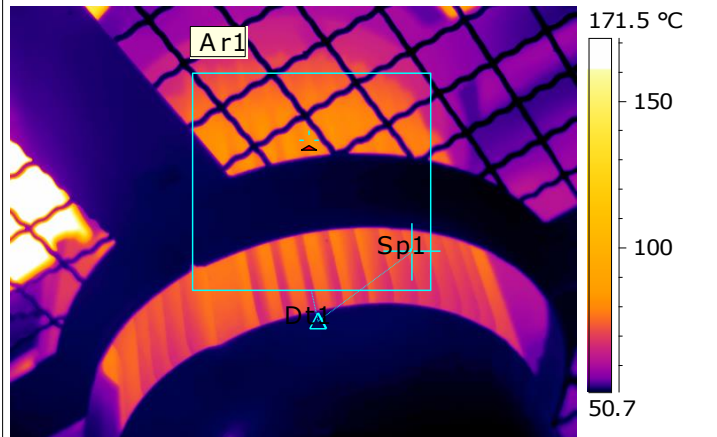
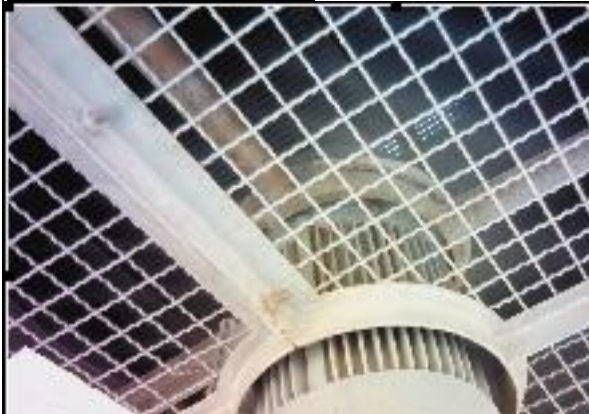
Location	GT No.7 Auxiliaries
Equipment	Disc cavity motor 1

Ar1 Max. Temperature	83.5 °C
Sp1 Max. Temperature	73.4 °C
Dt1 Value	10.0 °C

In maximum load, this AC motor, field windings (Ar1 of thermal image) model reference temperature should not exceed 100°C.

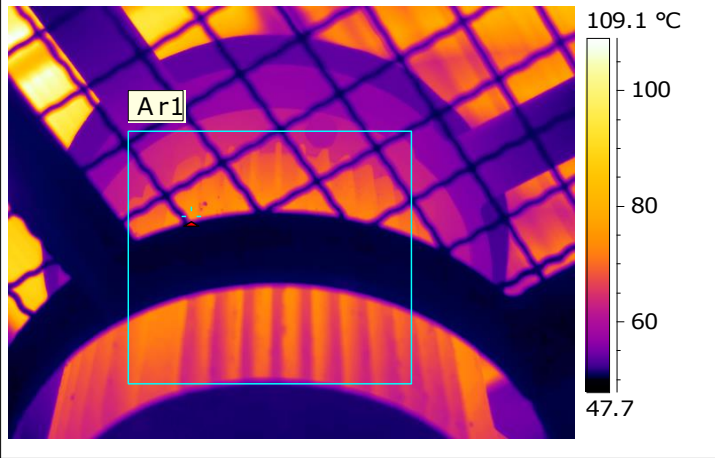
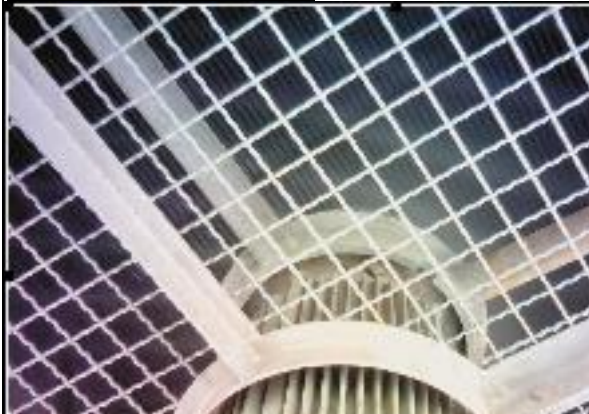
Location	GT No.7 Auxiliaries
Equipment	Disc cavity motor 2

Ar1 Max. Temperature	74.9 °C
----------------------	---------

In maximum load, this AC motor, field windings (Ar1 of thermal image) model reference temperature should not exceed 100°C.

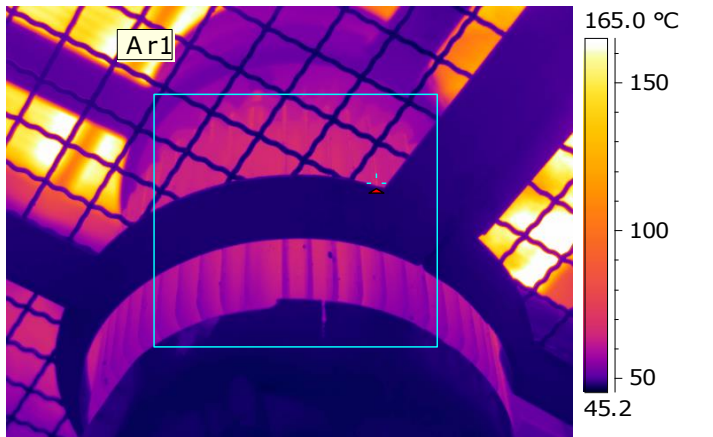
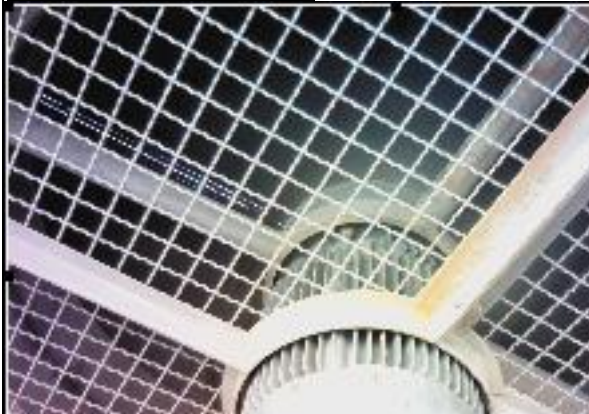
Location	GT No.10 Auxiliaries
Equipment	Disc cavity motor 1

Ar1 Max. Temperature	71.8 °C
----------------------	---------

In maximum load, this AC motor, field windings (Ar1 of thermal image) model reference temperature should not exceed 100°C.

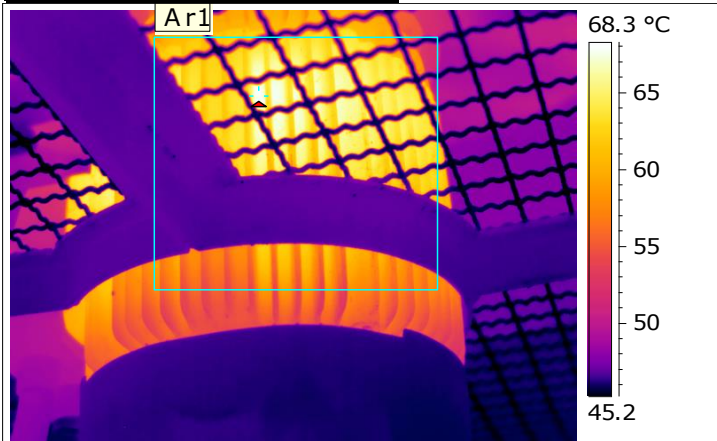
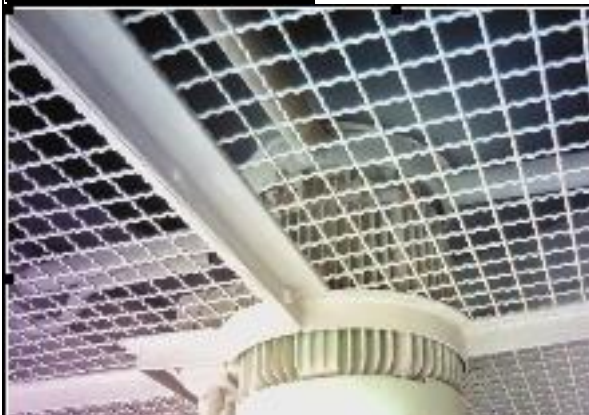
Location	GT No.10 Auxiliaries
Equipment	Disc cavity motor 2

Ar1 Max. Temperature	67.7 °C
----------------------	---------

In maximum load, this AC motor, field windings (Ar1 of thermal image) model reference temperature should not exceed 100°C.

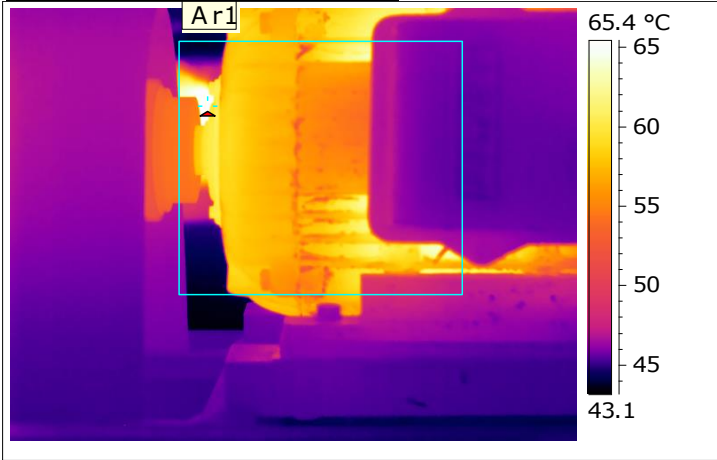
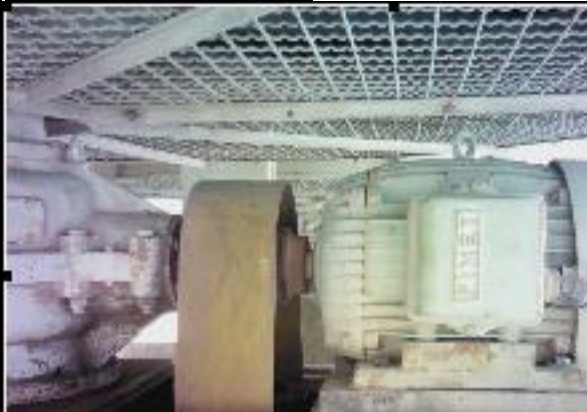
Location	GT No.10 Auxiliaries
Equipment	Lube oil cooling motor 1

Ar1 Max. Temperature	69.8°C
----------------------	--------

In maximum load, this bearing, plain types material of the motor (Ar1 of thermal image) model reference temperature should not exceed 121°C.

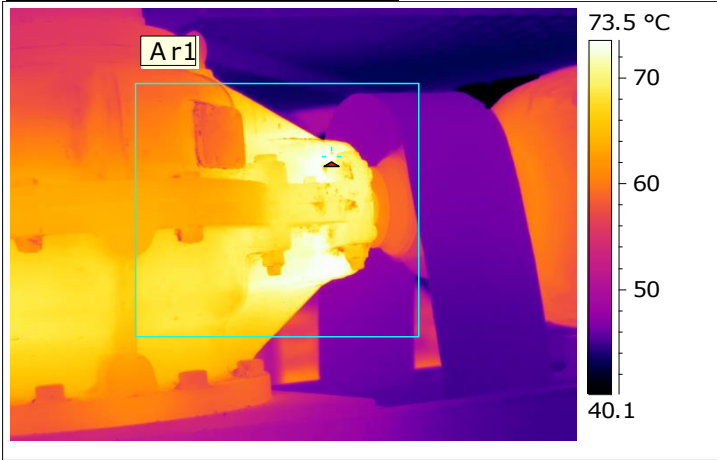
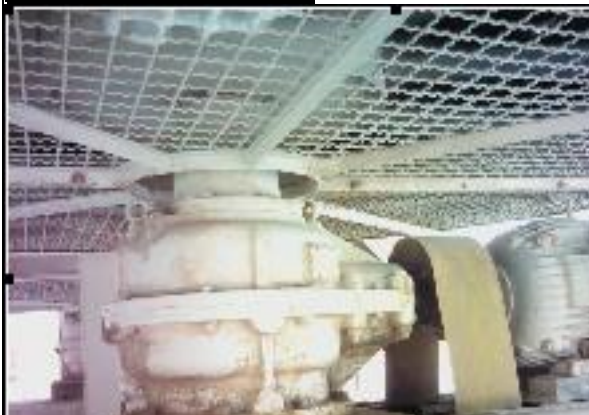
Location	GT No.10 Auxiliaries
Equipment	Gearbox 1

Ar1 Max. Temperature	73.5°C
----------------------	--------

In maximum load, this bearing, plain types material of the gearbox (Ar1 of thermal image) model reference temperature should not exceed 121°C.
