**Thermography Inspection for Electrical Equipment
at

**Thermal Inspection for Electrical Equipment
Using Advanced FLIR T640 Thermal Camera**

10/11/2014

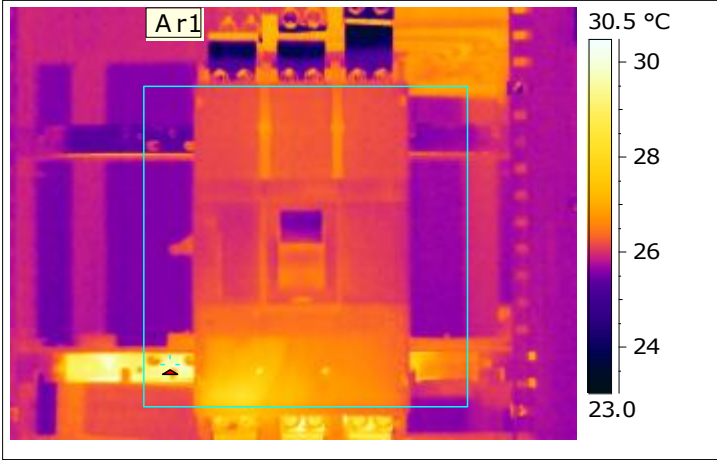
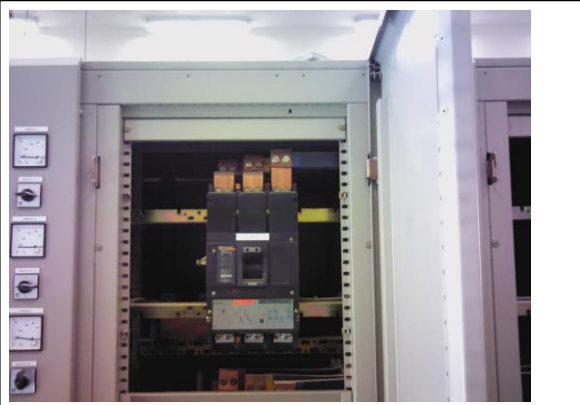
Image File Name	GR_0157.jpg
Image Date	11/10/2014
Image Time	10:44:12

Location	SCECO Building EB - 028
Equipment	Switchgear A + B – Panelboard 1

Atmospheric Temperature	20.0 °C
Relative Humidity	50%
Emissivity	0.95
Object Distance	1.0 m

Ar1 Max. Temperature	29.9 °C
----------------------	---------

In maximum load, this main circuit breaker (Ar1 of thermal image) model reference temperature should not exceed 70°C.

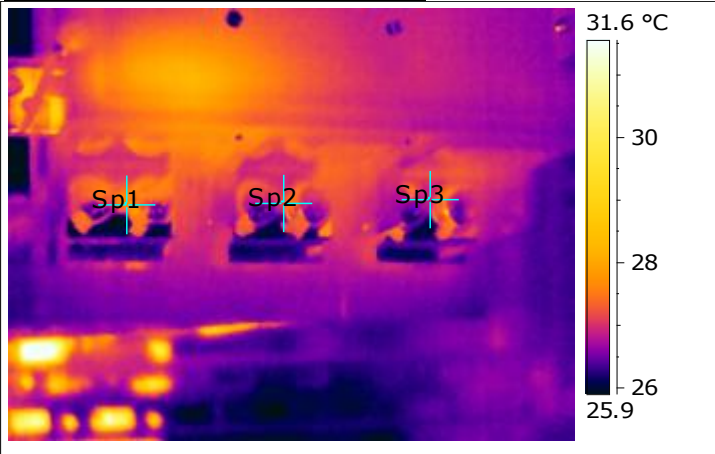
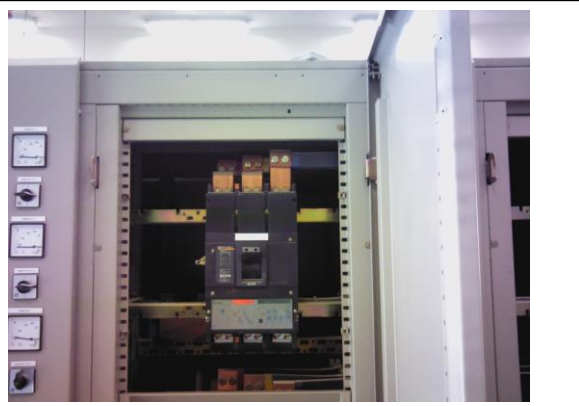
Image File Name	GR_0159.jpg
Image Date	11/10/2014
Image Time	10:44:56

Location	SCECO Building EB - 028
Equipment	Switchgear A + B – Panelboard 1

Atmospheric Temperature	20.0 °C
Relative Humidity	50%
Emissivity	0.95
Object Distance	1.0 m

Sp1 Max. Temperature	27.6 °C
Sp2 Max. Temperature	27.2 °C
Sp3 Max. Temperature	26.9 °C

In maximum load, this connectors and terminations (Sp1 to Sp3 of thermal image) model reference temperature should not exceed 90°C.

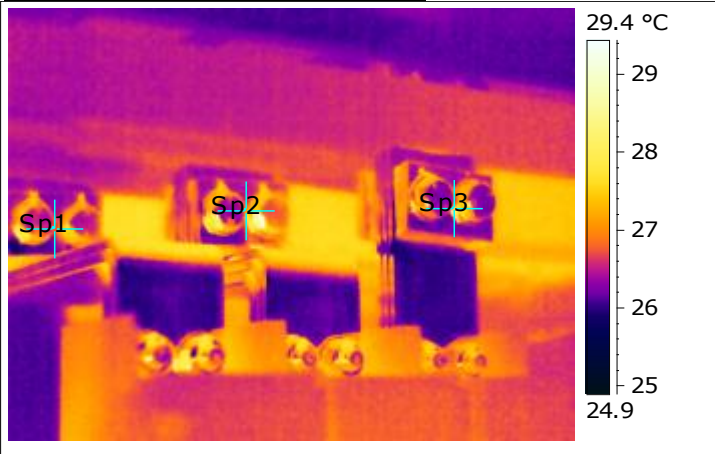
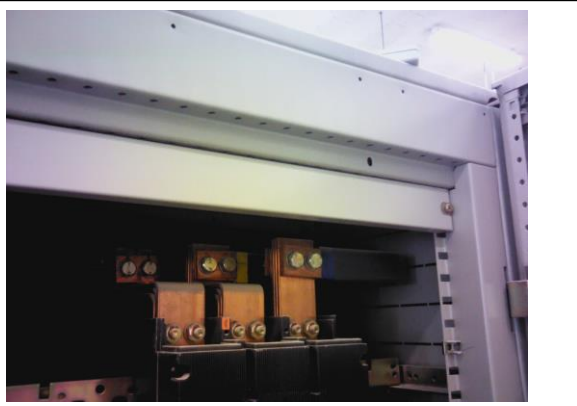
Image File Name	GR_0161.jpg
Image Date	11/10/2014
Image Time	10:45:11

Location	SCECO Building EB - 028
Equipment	Switchgear A + B – Panelboard 1

Atmospheric Temperature	20.0 °C
Relative Humidity	50%
Emissivity	0.95
Object Distance	1.0 m

Sp1 Max. Temperature	26.7 °C
Sp2 Max. Temperature	27.4 °C
Sp3 Max. Temperature	28.2 °C

In maximum load, this connectors and terminations (Sp1 to Sp3 of thermal image) model reference temperature should not exceed 90°C.

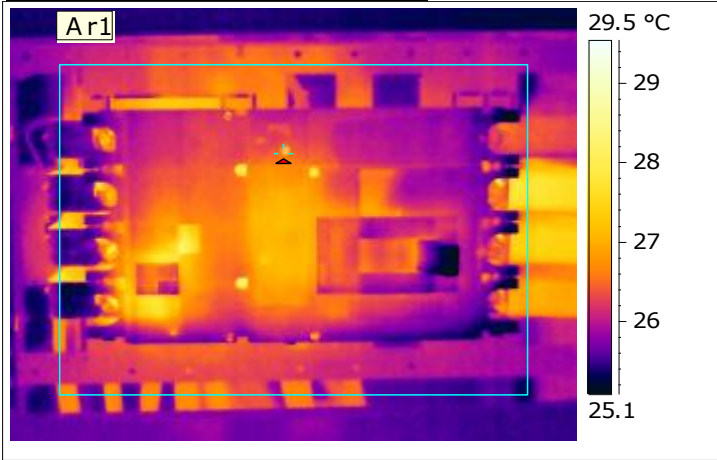
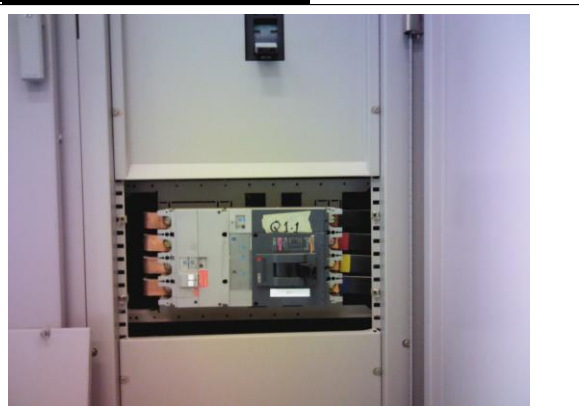
Image File Name	GR_0163.jpg
Image Date	11/10/2014
Image Time	10:45:33

Location	SCECO Building EB - 028
Equipment	Switchgear A + B – Panelboard 1

Atmospheric Temperature	20.0 °C
Relative Humidity	50%
Emissivity	0.95
Object Distance	1.0 m

Ar1 Max. Temperature	29.1 °C
----------------------	---------

In maximum load, this main circuit breaker (Ar1 of thermal image) model reference temperature should not exceed 70°C.

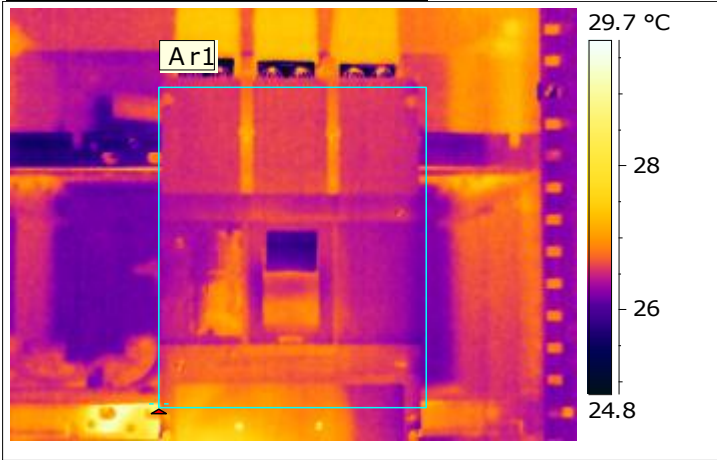
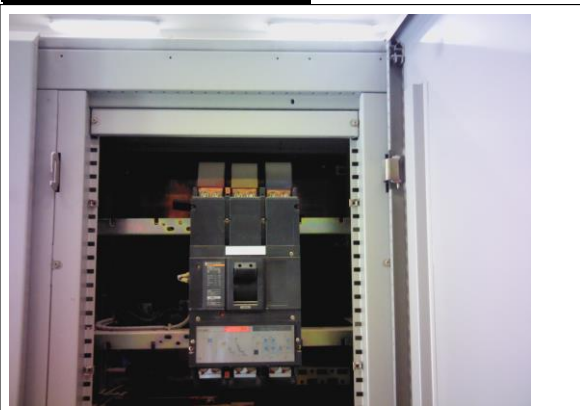
Image File Name	GR_0166.jpg
Image Date	11/10/2014
Image Time	10:47:41

Location	SCECO Building EB - 028
Equipment	Switchgear A + B – Panelboard 2

Atmospheric Temperature	20.0 °C
Relative Humidity	50%
Emissivity	0.95
Object Distance	1.0 m

Ar1 Max. Temperature	28.4 °C
----------------------	---------

In maximum load, this main circuit breaker (Ar1 of thermal image) model reference temperature should not exceed 70°C.

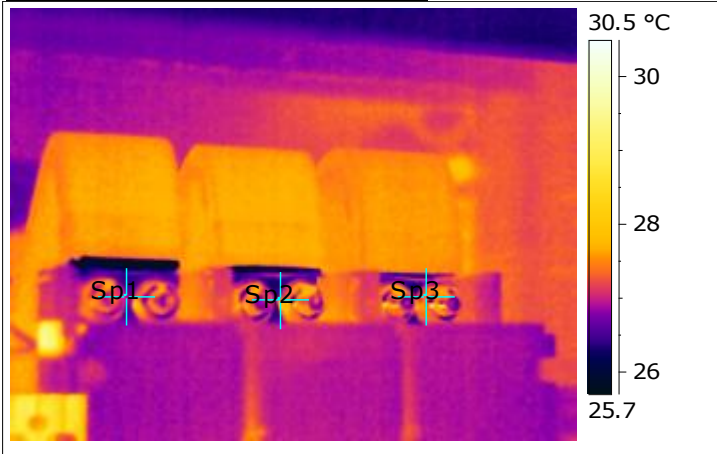
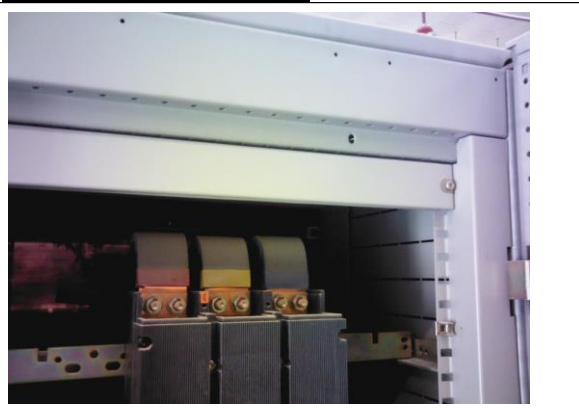
Image File Name	GR_0168.jpg
Image Date	11/10/2014
Image Time	10:48:04

Location	SCECO Building EB - 028
Equipment	Switchgear A + B – Panelboard 2

Atmospheric Temperature	20.0 °C
Relative Humidity	50%
Emissivity	0.95
Object Distance	1.0 m

Sp1 Max. Temperature	26.9 °C
Sp2 Max. Temperature	27.7 °C
Sp3 Max. Temperature	27.5 °C

In maximum load, this connectors and terminations (Sp1 to Sp3 of thermal image) model reference temperature should not exceed 90°C.

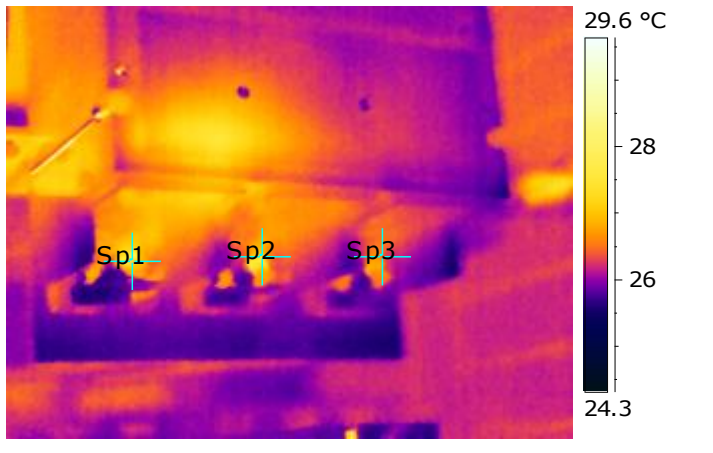
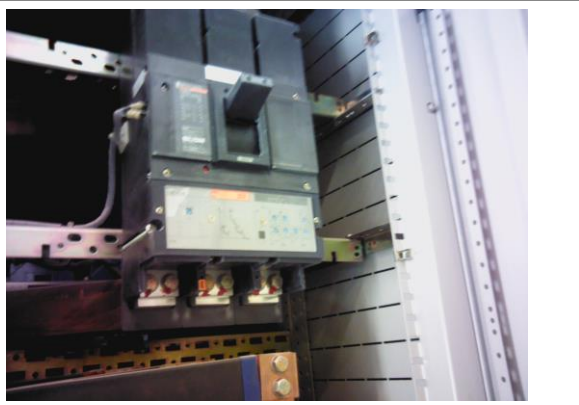
Image File Name	GR_0170.jpg
Image Date	11/10/2014
Image Time	10:48:52

Location	SCECO Building EB - 028
Equipment	Switchgear A + B - Panelboard 2

Atmospheric Temperature	20.0 °C
Relative Humidity	50%
Emissivity	0.95
Object Distance	1.0 m

Sp1 Max. Temperature	27.2 °C
Sp2 Max. Temperature	27.9 °C
Sp3 Max. Temperature	26.4 °C

In maximum load, this connectors and terminations (Sp1 to Sp3 of thermal image) model reference temperature should not exceed 90°C.

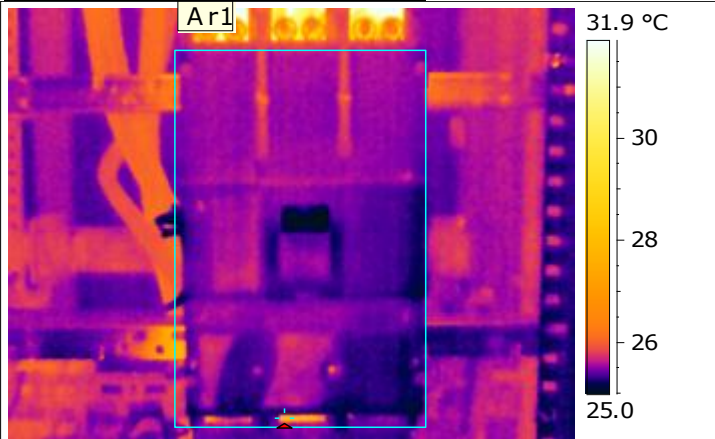
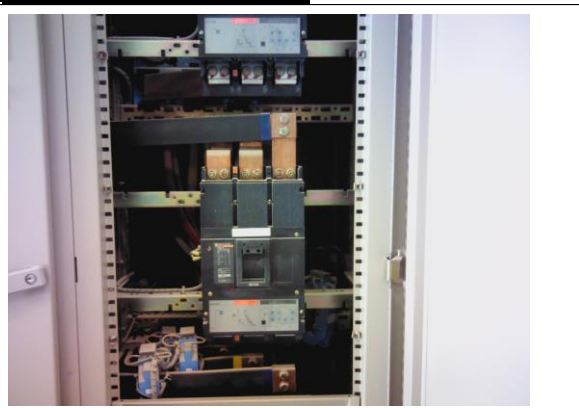
Image File Name	GR_0172.jpg
Image Date	11/10/2014
Image Time	10:49:17

Location	SCECO Building EB - 028
Equipment	Switchgear A + B – Panelboard 2

Atmospheric Temperature	20.0 °C
Relative Humidity	50%
Emissivity	0.95
Object Distance	1.0 m

Ar1 Max. Temperature	28.7 °C
----------------------	---------

In maximum load, this main circuit breaker (Ar1 of thermal image) model reference temperature should not exceed 70°C.

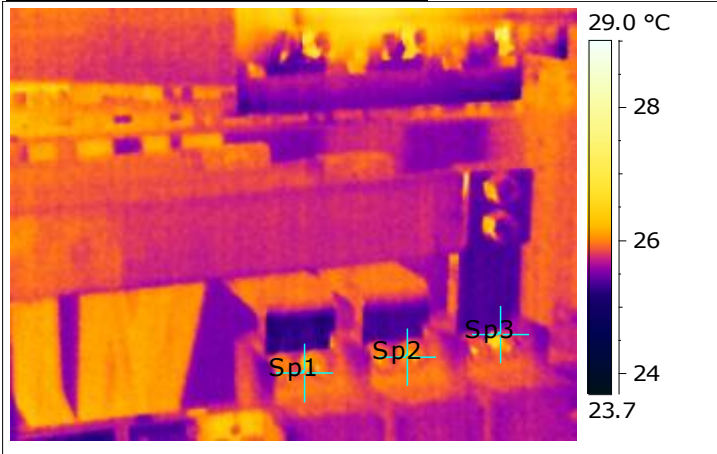
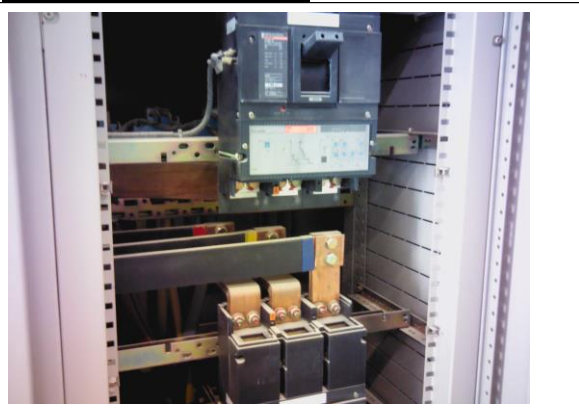
Image File Name	GR_0174.jpg
Image Date	11/10/2014
Image Time	10:49:45

Location	SCECO Building EB - 028
Equipment	Switchgear A + B – Panelboard 2

Atmospheric Temperature	20.0 °C
Relative Humidity	50%
Emissivity	0.95
Object Distance	1.0 m

Sp1 Max. Temperature	26.0 °C
Sp2 Max. Temperature	25.9 °C
Sp3 Max. Temperature	25.9 °C

In maximum load, this connectors and terminations (Sp1 to Sp3 of thermal image) model reference temperature should not exceed 90°C.

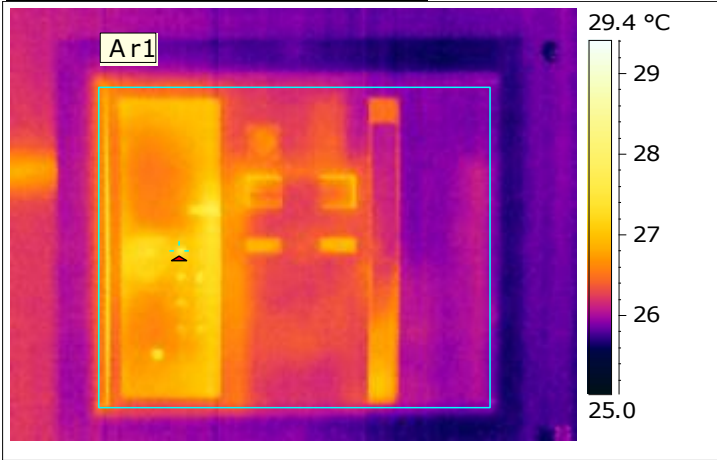
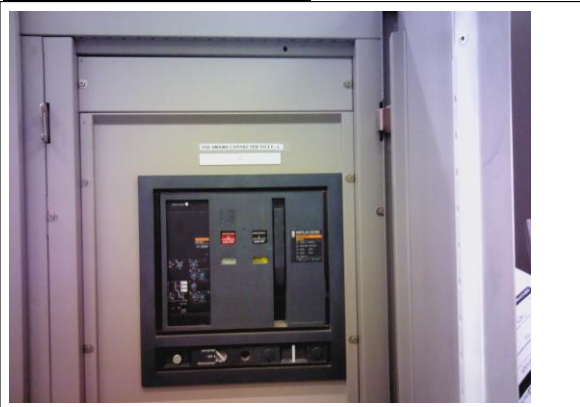
Image File Name	GR_0179.jpg
Image Date	11/10/2014
Image Time	10:51:55

Location	SCECO Building EB - 028
Equipment	Switchgear A + B – Panelboard 3

Atmospheric Temperature	20.0 °C
Relative Humidity	50%
Emissivity	0.95
Object Distance	1.0 m

Ar1 Max. Temperature	28.6 °C
----------------------	---------

In maximum load, this main circuit breaker (Ar1 of thermal image) model reference temperature should not exceed 70°C.

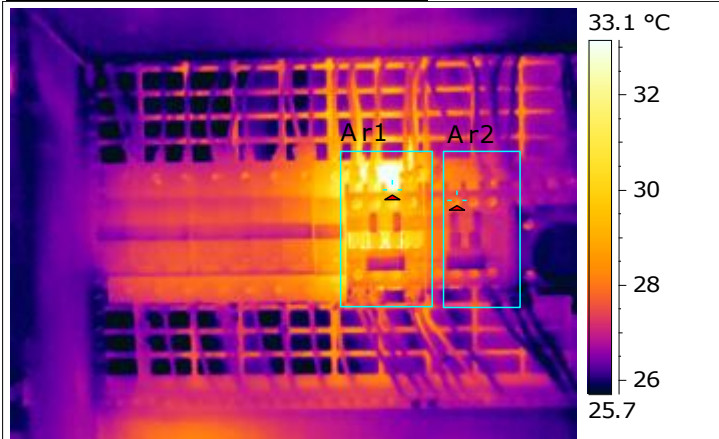
Image File Name	GR_0183.jpg
Image Date	11/10/2014
Image Time	10:54:51

Location	SCECO Building EB - 028
Equipment	Switchgear A + B – Panelboard 3

Atmospheric Temperature	20.0 °C
Relative Humidity	50%
Emissivity	0.95
Object Distance	1.0 m

Ar1 Max. Temperature	38.2 °C
Ar2 Max. Temperature	29.6 °C

In maximum load, this magnetic contactor (Ar1 of thermal image) model reference temperature should not exceed 90°C.

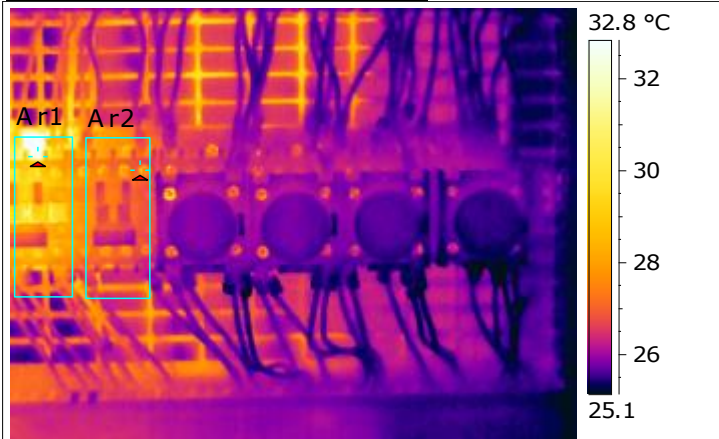
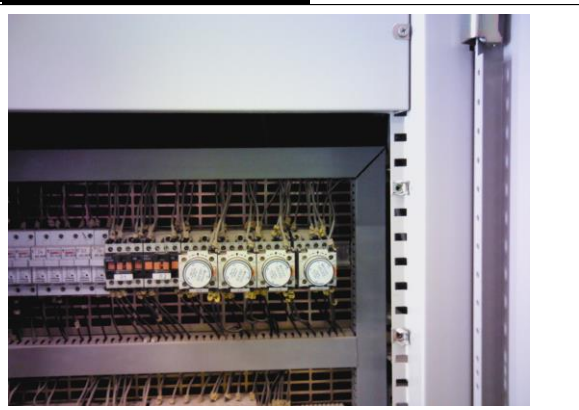
Image File Name	GR_0185.jpg
Image Date	11/10/2014
Image Time	10:55:05

Location	SCECO Building EB - 028
Equipment	Switchgear A + B – Panelboard 3

Atmospheric Temperature	20.0 °C
Relative Humidity	50%
Emissivity	0.95
Object Distance	1.0 m

Ar1 Max. Temperature	37.5 °C
Ar2 Max. Temperature	30.8 °C

In maximum load, this magnetic contactor (Ar1 of thermal image) model reference temperature should not exceed 90°C.

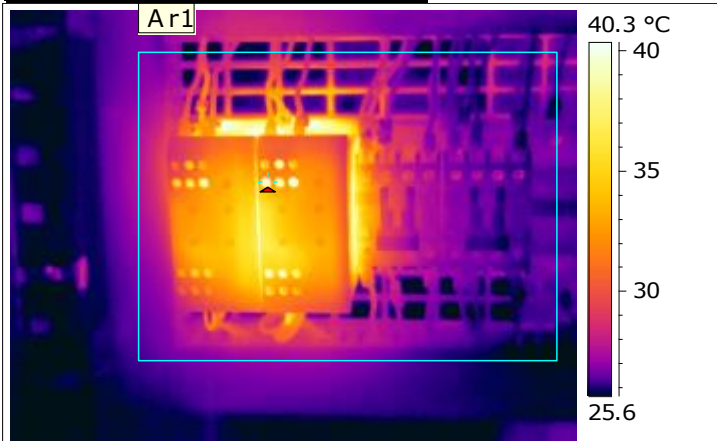
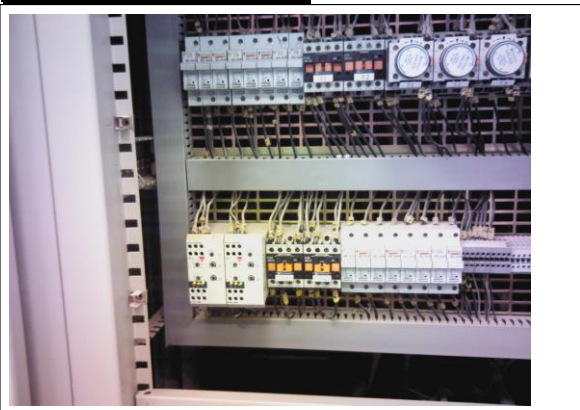
Image File Name	GR_0187.jpg
Image Date	11/10/2014
Image Time	10:55:18

Location	SCECO Building EB - 028
Equipment	Switchgear A + B – Panelboard 3

Atmospheric Temperature	20.0 °C
Relative Humidity	50%
Emissivity	0.95
Object Distance	1.0 m

Ar1 Max. Temperature	47.7 °C
----------------------	---------

In maximum load, this miniature circuit breaker (Ar1 of thermal image) model reference temperature should not exceed 50°C.

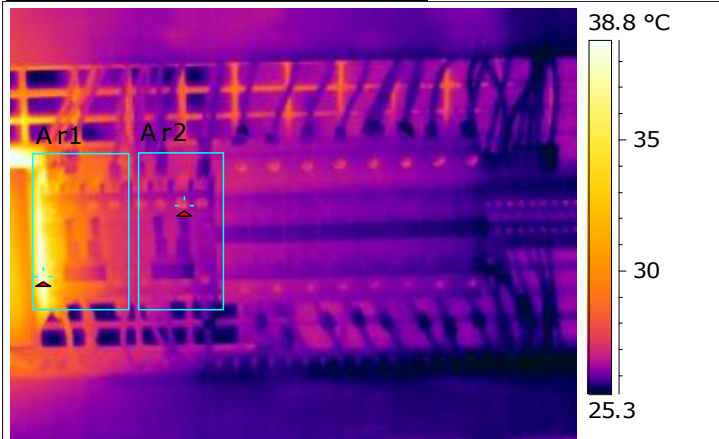
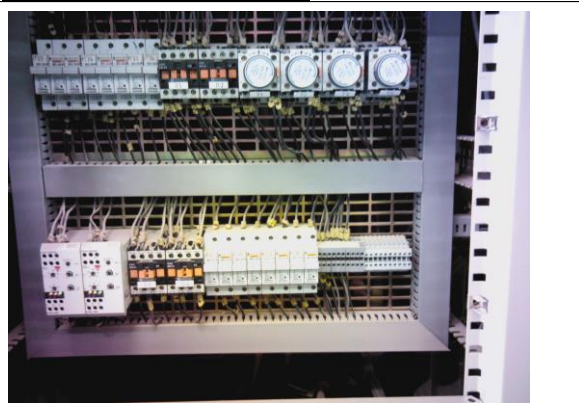
Image File Name	GR_0189.jpg
Image Date	11/10/2014
Image Time	10:55:28

Location	SCECO Building EB - 028
Equipment	Switchgear A + B – Panelboard 3

Atmospheric Temperature	20.0 °C
Relative Humidity	50%
Emissivity	0.95
Object Distance	1.0 m

Ar1 Max. Temperature	39.6 °C
Ar2 Max. Temperature	29.2 °C

In maximum load, this magnetic contactor (Ar1 of thermal image) model reference temperature should not exceed 90°C.
